Confirmation of diagnosis

Gas Compressor Crosshead Pin / Bush Clearance Concern

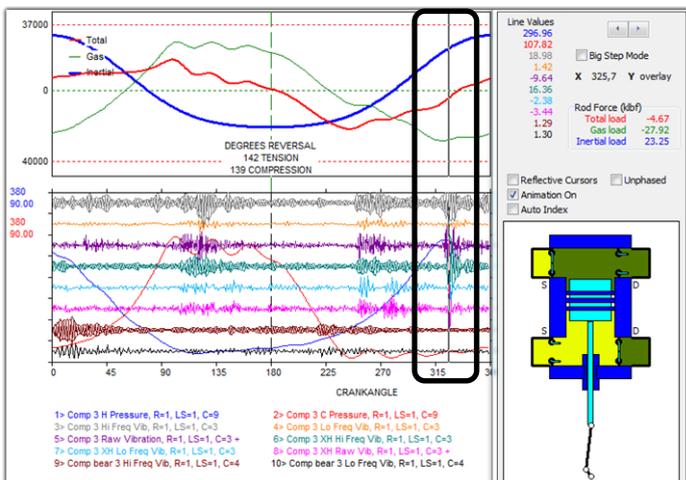
Graph 1. Gas pressure (green), piston (blue) and total (red).

An impact on the crosshead is observed at 325.7°, at the same moment of zero load, indicating that the impact is the product of a clearance deviation in the crosshead Bush / Pin assembly.

As a conclusion of this analysis it was preconized to relieve gaps of the corresponding throw assembly in order to be able to compare the metrological survey with the Windrock visualized impact.

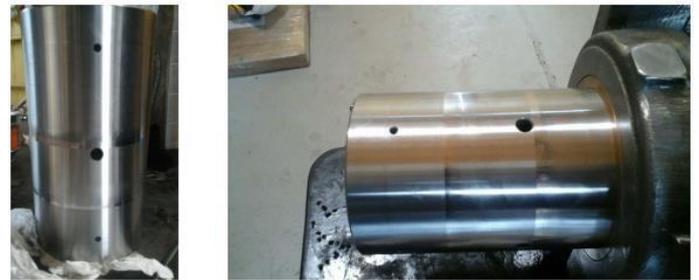
Figure 1: Pin surface.

The compressor throw#3 was disassembled and abnormal markings were found on the surface of the pin (Figure 1), mainly in the areas adjacent to the lubrication groove of the connecting rod bushing.

As can be seen in Tables 1 and 2, gap measurements were performed on six different transverse planes on each direction. Table 1 shows the gaps for connecting rod N°3, noting that for plane 3 in directions B and C it is seen that the gap is the minimum acceptable, but as the worn zone was found it can be said that the previous gap was smaller than minimum.
