CASE STUDY: Interference

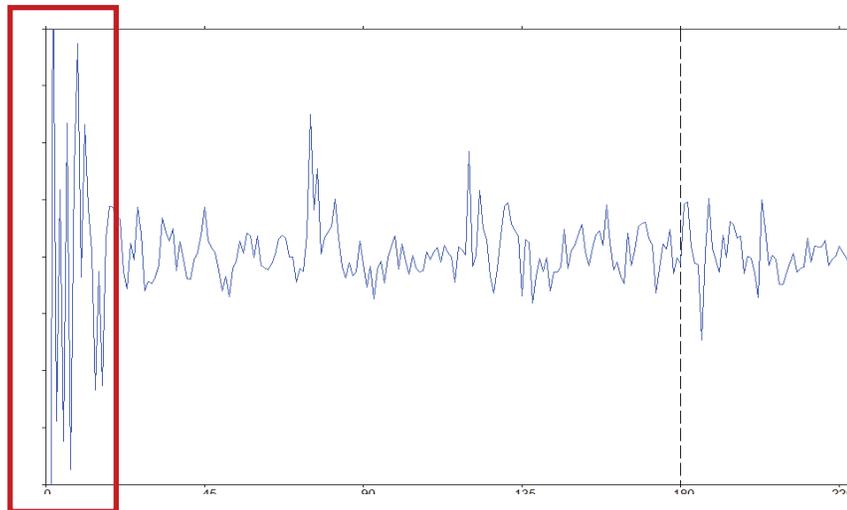
Figure 1 - Data from 6320/PA showing head knocking

The compressor was analyzed by the customer using a Windrock 6320/PA. After reviewing the data, the customer believed the knocking sound was caused by a head knock (Figure 1). The customer contacted the manufacturer who disagreed, claiming that it was not possible for that to happen and they would need a second opinion before taking any action. The customer then sent the database to Windrock Tech Services who confirmed without a doubt that the data was showing a head knock.

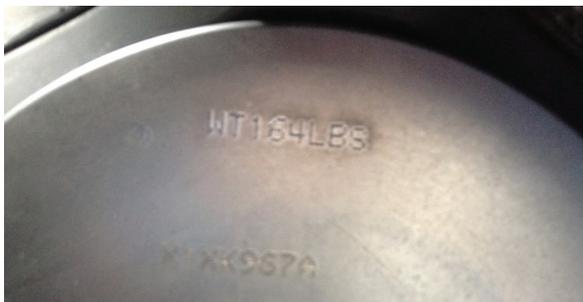
Figure 2 - Piston with Manufacturers Product Code

The compressor was taken apart and the results of the impact could be viewed and photographed. It was clear that the piston was hitting the cylinder, as the piston's model numbers were stamped backwards into the cylinder (Figures 2 & 3). As a result of these findings, the Manufacturer paid to have the piston machined 0.060" in order to eliminate startup impact. This saved the refinery an estimated \$500,000 in repairs had the machine suffered a catastrophic failure.
