CASE STUDY: Power Generation Plant Mechanical Issue on a Sulzer ZA40S

Diesel Engine Report
Diesel Engine Examples and Case Studies
Sulzer 16ZV40/48 Piston Hitting Valves

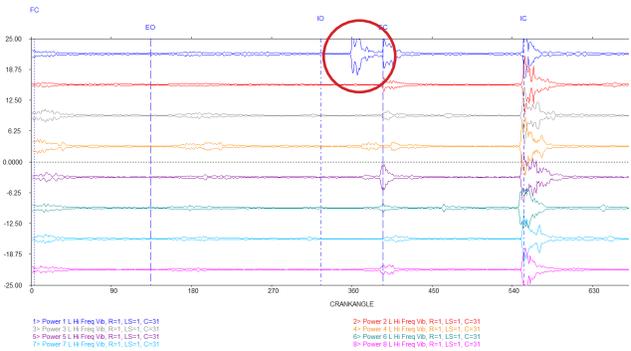
Comprehensive engine analysis was performed which determined that the mechanical ticking was occurring just prior (1 deg.) to Top Dead Center (TDC) on the scavenging stroke. With the piston at or very near TDC on the scavenging stroke, both the exhaust valves and intake valves are open. As a result of the analysis, a maintenance activity was performed which indicated the valves were touching the piston at TDC. It was also determined that a 1mm shim or spacer was installed, not the required 2mm spacer.

(Figure 2) Piston crown has a polished ring indicating the valves are hitting the piston each stroke.

As shown in the engine report below (Figure 1), it should be noted that even though the peak pressure and compression pressure were the highest, the peak pressure angle was earliest, the exhaust temperature was below the engine average. This is caused by the higher compression pressure (17%) due to the smaller clearance volume which in turn results in earlier combustion and a higher peak pressure. When the cylinder 1L head was removed on Engine E8 (Figure 2), it could be seen that the piston crown had a polished ring with no carbon on it indicating that the valves were hitting the piston each scavenge stroke and as the piston crown rotated it kept a ring free of carbon. The valves also exhibited damage. Due to the damage to the valves from being impacted, all were replaced and same head re-installed with the correct 2 mm shim. After this maintenance, the engine noise was eliminated and peak pressure monitoring indicated the peak pressure was back to normal.
