Case Studies

Field Reports from Windrock

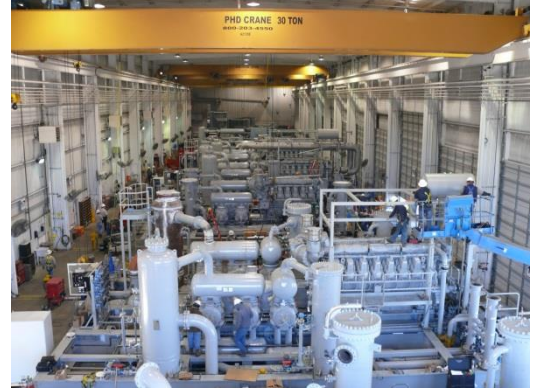
The Windrock On-Guard monitoring systems were designed using the C-Guard™ modules. These provide monitoring of:

- Head & Crank-end Pressures
- Suction/Discharge Temperatures
- Rod Drop/Rod Runout
- Cross Head Impacting
- Cylinder Head Velocity

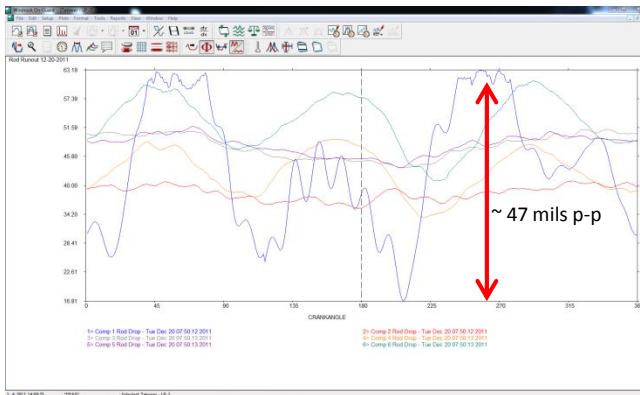
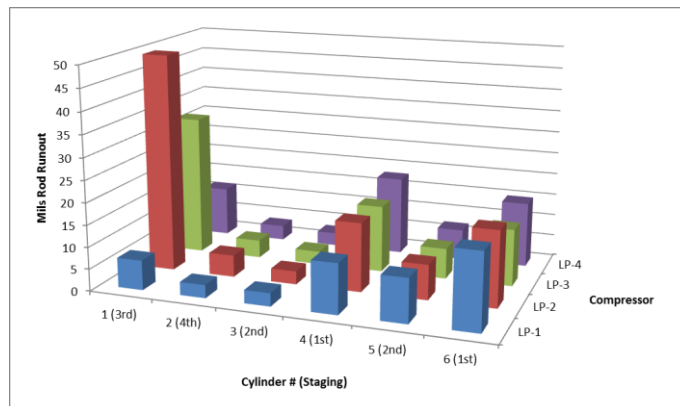
After examination of the compressor, it was determined that crosshead lubrication lines had been left disconnected on the two cylinders that exhibited the high Rod Runout values on the Windrock Monitoring system. The compressor commissioning mechanic found that the babbit surfaces on the two affected cylinders' crossheads were damaged. Had the unit not been shutdown in time the likely result would have been a damaged crankshaft resulting in over \$US 1,000,000 in repairs.
